# Manhole Inspection Summary

Manhole # S35YY\_036MH

Insp Date: **12/22/06 11:50 AM**

**Location** Address: **100 32ND ST**

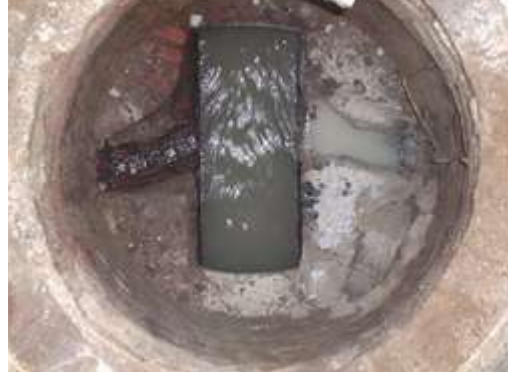
Top View

☐ Parged ☒ **Debris** (not Condition related)

**Steps** Count: **2** Missing: **2** ☒ **Corroded**

Corroded and missing steps. Bench debris.

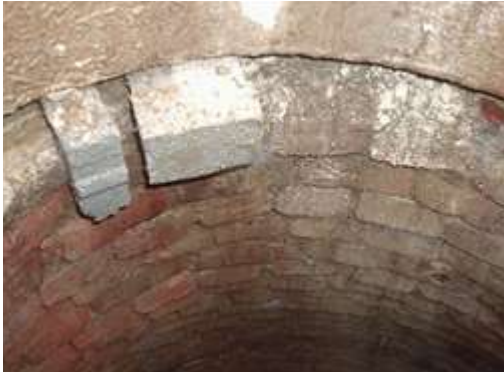
Defect

**Frame** Offset: **3** (in.)

☒ **Leaks**

Condition: ☐ Sound ☐ Cracked ☐ Root Intrusion ☒ **Loose Brick** ☒ **Deteriorated**

Infiltration: ☐ None ☒ **Joint** ☐ Cracks ☐ Mortar ☐ Roots ☒ **Wall**

Frameleaks. Frame offset. Adjustment deterioration, loose brick and infiltration.

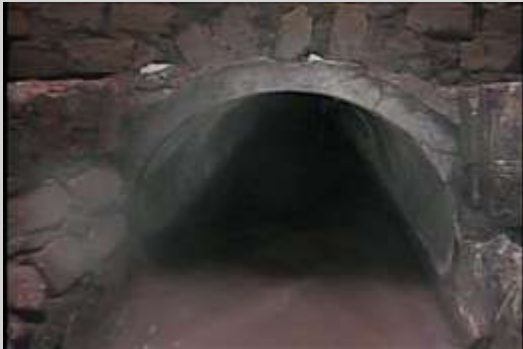
### 18 in. Circular Gravity Sewer Pipe Out @ 12 O'Clock

Channel deterioration.

Infiltration: **None** Pipe Seal Cond: **Cracked**

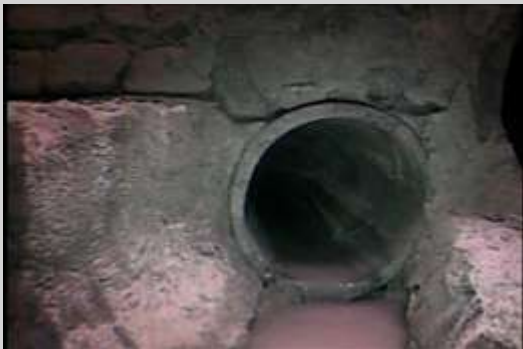
### 8 in. Circular Gravity Sewer Pipe In @ 3 O'Clock

Infiltration: **Evidence** Pipe Seal Cond: **Cracked**

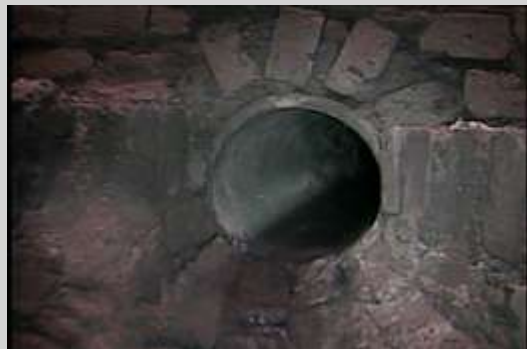
8 in. Circular Gravity Sewer

Barrel deterioration and infiltration. Channel deterioration.

Infiltration: **Evidence**
